Avid Configuration Guidelines Dell T5500 Quad-Core Workstation

The Dell T5500 workstation has completed qualification and is approved for Avid Media Composer Soft 6.0, Symphony Soft 6.0, NewsCutter 10.0, Mojo DX and Nitris DX.

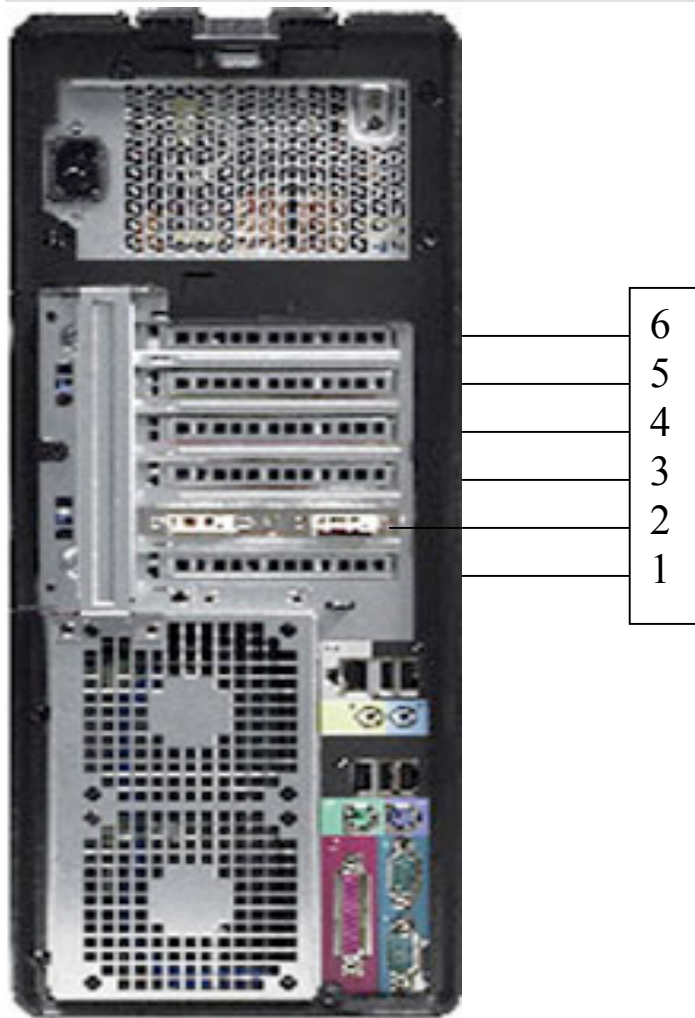
Disabling the TDM Service on Dell Workstations

The Dell Workstations require the TDM service to be disabled for customers to use the internal disk for capture or playback. The TDM service is used for drive encryption which slows the performance of the internal drive. Below are instructions on how to disable the service. Once the service is disabled it will remain disabled until the service status is changed manually.

- *Right click on Computer and select Manage*
- *Turn down Services and Applications arrow and select Services*
- *Scroll down to TDM Services and right click on select properties*
- *Service Status select stop*
- *Change start type: Disabled and Apply*
- *Close all open windows and application*
- *Restart system*
